INVESTIGATION

Bryson Crash

RFI#22SC0121

INVESTIGATION OF THE BRYSON CRASH**EXPERT'S REPORT****OCTOBER 12, 2023****A. INTRODUCTION**

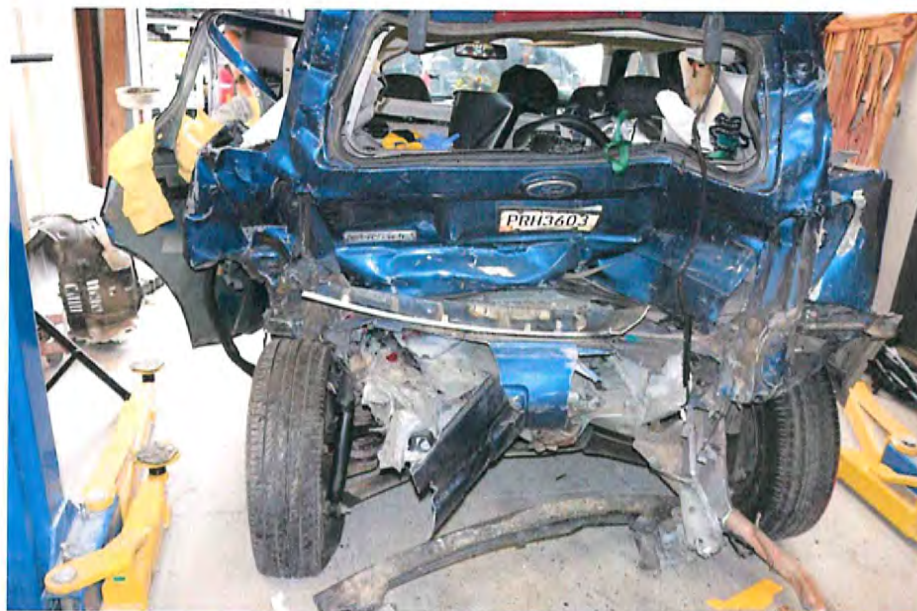
Kelley's 2008 Ford Escape was a small 4-door SUV with two-wheel drive and a 3.0L gasoline engine, VIN 1FMCU03178KA77952. The rear end damage sustained by the Ford Escape can be seen in Image 4 which shows extensive structural deformation of the entire rear end of the vehicle and the rear bumper detached. Image 5 shows the rear passenger compartment with the rear child seat pushed forward into the back of the front driver's seat.

Image 4 – Ford Escape at Car Crafters, Towing Company Facility

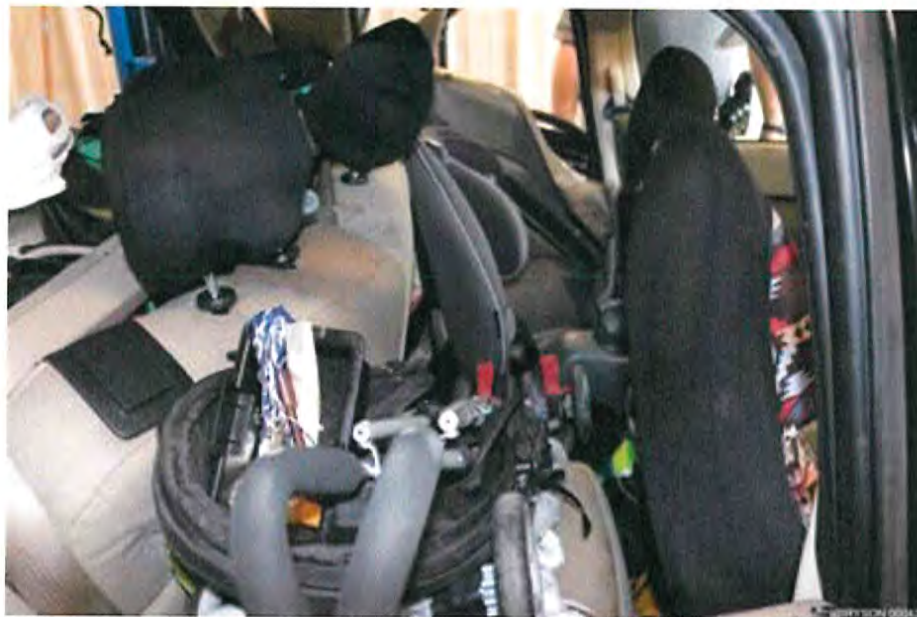
Image 5 – Ford Escape at Car Crafters, Towing Company Facility

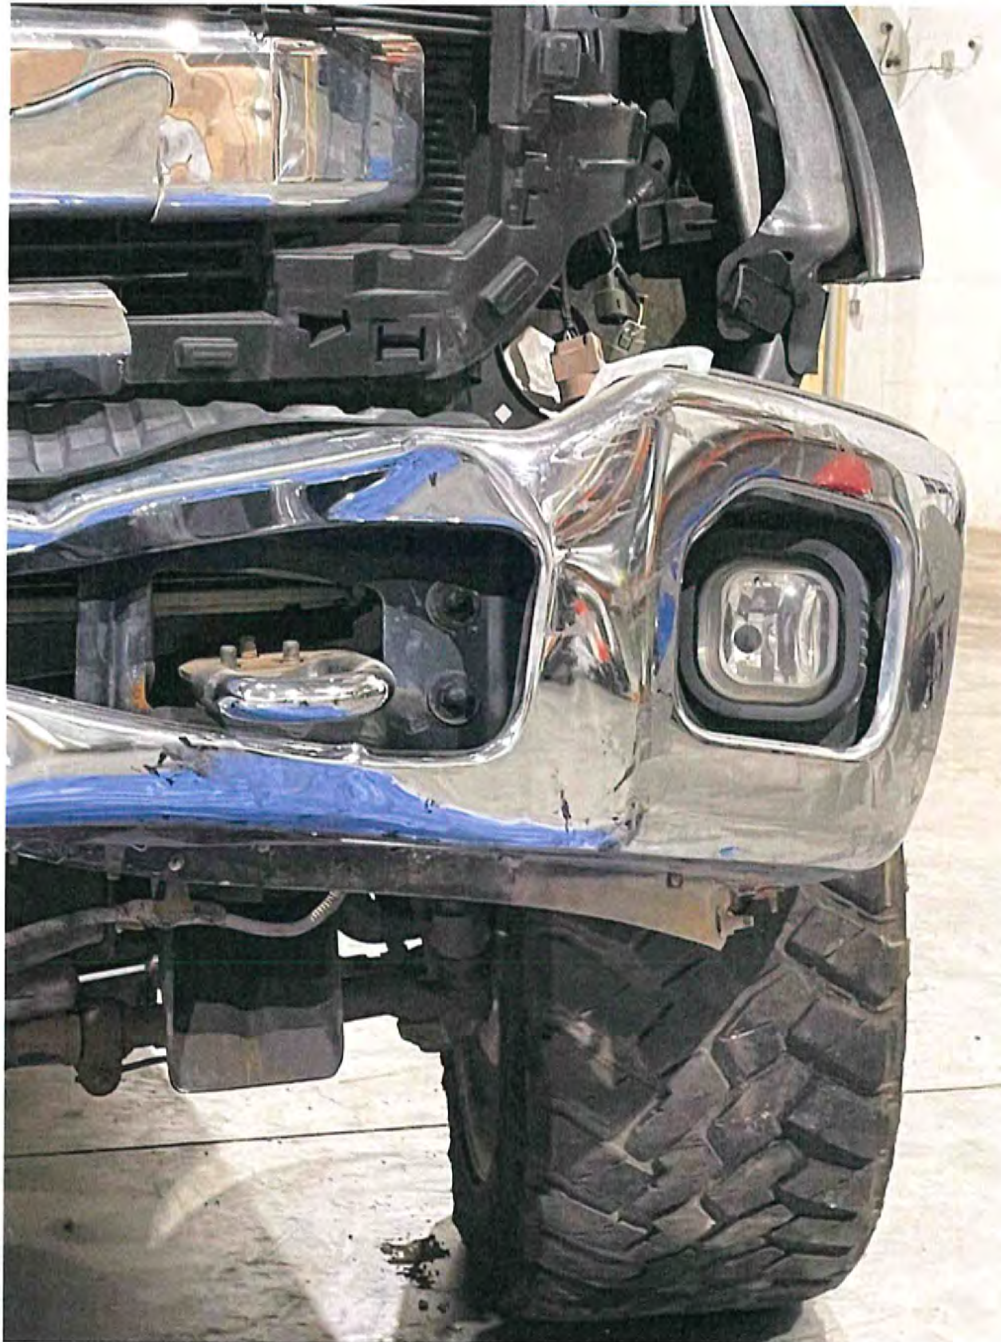
- Minimal deformation to the front end of the F250 (Image 6).
- Local deformation to the center of the bumper in a vertical direction. The presence of two Secondary Energy Absorbing Structure (SEAS) brackets showing minimal deformation or contact marks (Images 7 & 8).

Image 8 – Bumper & Left SEAS

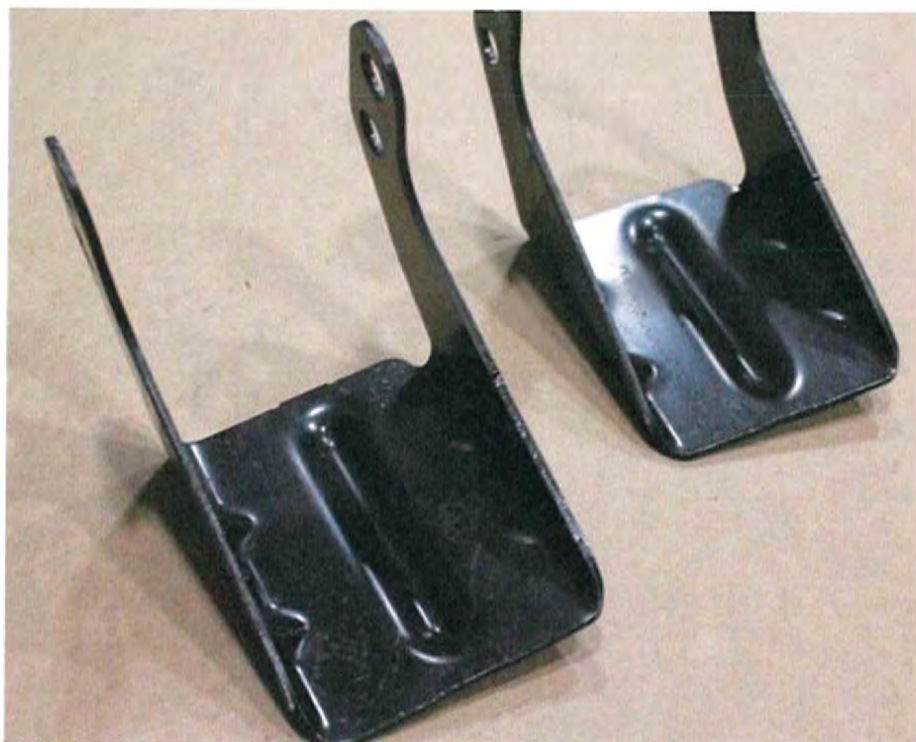
Image 26 – 2016 Ford F250 SEAS Brackets

The SEAS brackets fitted to the 2016 Ford F250 (image 26) are relatively simple, stamped U-shaped brackets that are bolted to the main frame rail in two locations each. Each bracket costs about \$25 when

purchased from a Ford dealer as a replacement part. Rough Country could have developed components to maintain vehicle compatibility and could have advised customers to fit the new components when using a lifted vehicle on public roadways. Rough Country has the capability to design and produce new versions of the U-shaped brackets with modified geometry to account for the ride height increase of the lift kit and to ensure it satisfied the 16 inch height and 100 kN load requirement of the EVC agreement. The SEAS brackets are bolted to the frame rail and so removing and replacing them with new components is straight forward and consistent with how the lift kit is installed. The alternative design of new SEAS brackets would not affect the utility of the vehicle on-road and could be easily removed for off-road use, if necessary.
